**Preventative Measures for  
Alkali-Silica Reaction: The  
Kingston Outdoor Exposure Site  
for ASR - After 16 Years**

MERO-031

**June 2008**

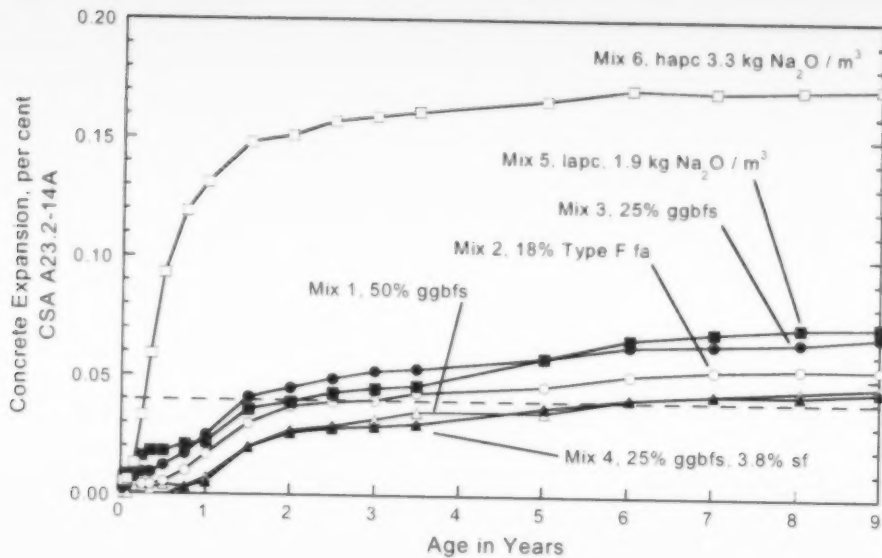
Figure 1. Expansion of Concrete Prisms in the Laboratory at 38°C

A paper providing the results after 8 years exposure was previously published (Rogers et al, 2000). Table 4 shows the results of accelerated mortar bar expansion testing. Figure 1 shows the 38°C expansion of the concrete prisms made with the six different mixtures. Figures 2, 3, and 4 show the length change of the unreinforced beams, reinforced beams, and pavement

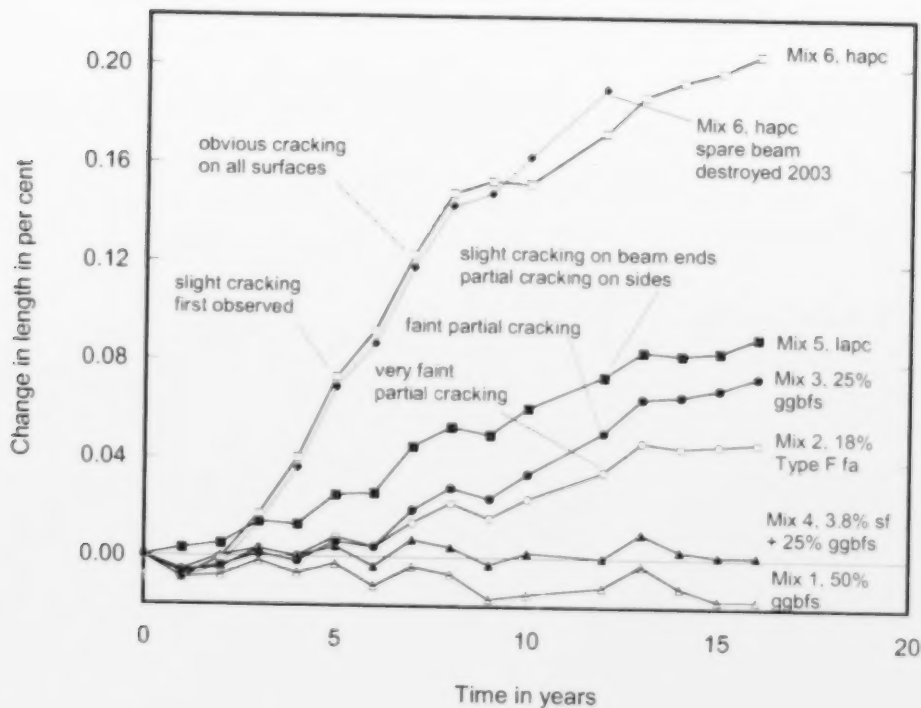
Figure 2. Expansion of Outdoor Exposed Unreinforced Concrete Beams

slabs, respectively. In these data, no correction has been made for the thermal expansion effects caused by making annual measurements at slightly different ambient temperatures each year. As a result, the curves are not smooth. The error is judged to be small. In Figure 2, it can be seen that expansion of Mixture 6 (high-alkali cement) started after 2 years, and visible cracking was first observed at an age of 5 years. By 7 years, pattern cracking was obvious on all beam surfaces of Mixture 6.

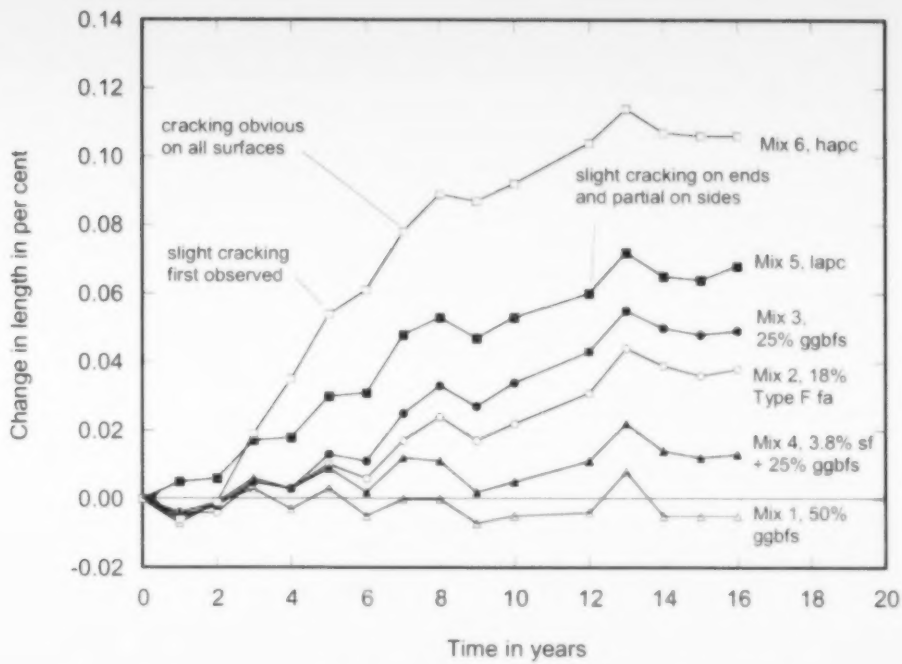
Figure 3. Expansion of Outdoor Exposed Reinforced Concrete Beams

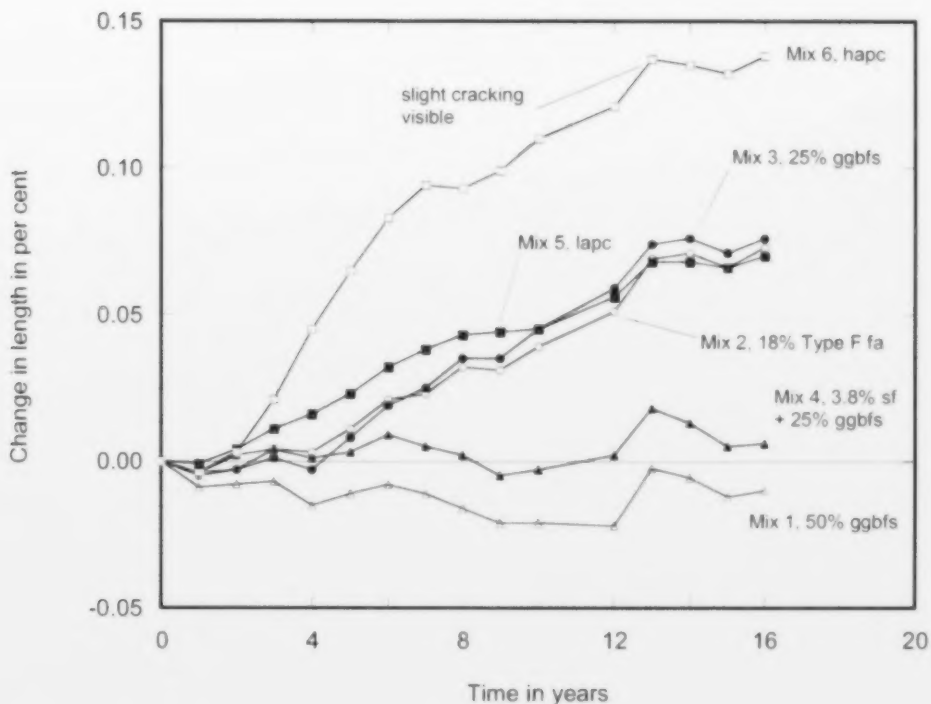
Figure 4. Expansion of Outdoor Exposed Pavement Slabs

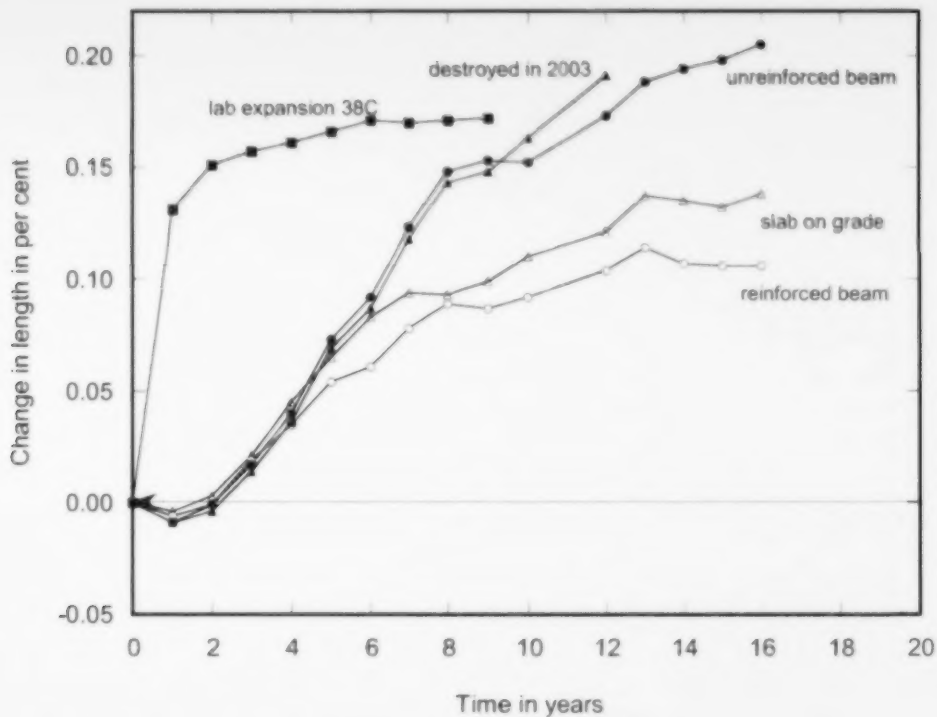
Figure 5. Expansion of Mixture 6 (High-Alkali Cement) in Various Elements

Figure 5 shows that the presence of 1.41% by area of longitudinal steel reinforcement has restrained the expansion by 40% of that of the non-reinforced beams of Mixture 6 (high-alkali cement). Hobbs (1988) reported that 0.91% steel reinforcement gave a significantly greater reduction of expansion of between 65 and 70%. In his studies, the unrestrained expansion was significantly greater (0.5-0.8% at about 100 days) using an artificial reactive aggregate under laboratory conditions. This may have given unrealistic restraint compared with real conditions where greater creep may be expected.

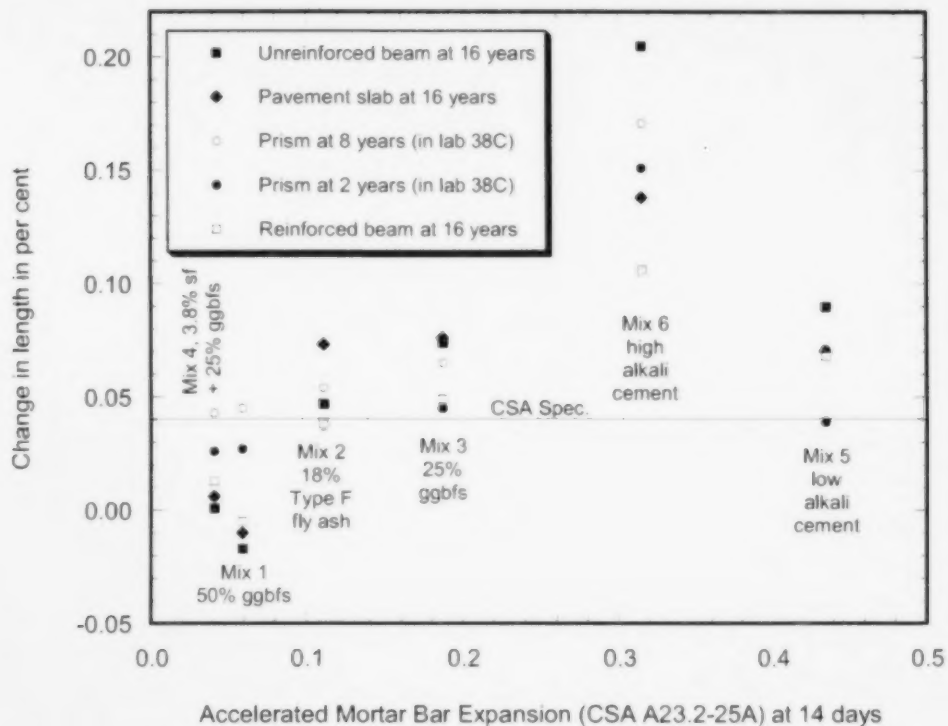
Figure 6. Mortar Bar Expansion Versus Concrete Field Expansion at 16 Years

In contrast to the high-alkali cement beams, the companion pavement slab has shown little cracking beyond that noted on the edges at 5 years. Figure 6 shows that, up to about 6 years, the expansion of the slab was similar to that of the non-reinforced beams. After 6 years, the expansion has slowed so that, after 9 years, the expansion of the slab is about that of the reinforced beam. The reason for this is unknown. It is possible that expansion is being constrained by a combination of friction between the slab and the underlying and surrounding well-compacted granular base and restraint of the 60 mm thick asphaltic concrete that was installed around the perimeter of the slab. Both these materials have a low modulus compared with that of the concrete and it is hard to conceive that they would be able to slow expansion.

Figure 6 shows the relationship between mortar bar expansion and concrete expansion. It should be noted that the 14-day mortar bar test is known not to be valid for determining the benefits of low-alkali Portland cement (Hooton and Rogers, 1989). The Canadian standard for concrete (CSA A23.2-27A, 2004) requires that expansion of concrete prisms be less than 0.04% at 1 year to deem an aggregate to be non-deleteriously reactive. It can be seen that, after 14 years, concrete in outdoor exposure gave less than 0.04% expansion for Mixtures 1 (50% ggbfs) and 4 (25% ggbfs and 3.8% silica fume). These mixtures also gave less than 0.10% expansion in the mortar bar test at 14 days. Currently, the advice given in CSA standards (A3000 and A23.2-28A) is that, when mortar bars give less than 0.10% expansion at 14 days with a reactive aggregate and a supplementary cementing material, the material in the proportion used will prevent deleterious alkali-silica reaction. Data given in Figure 6 confirms this advice.

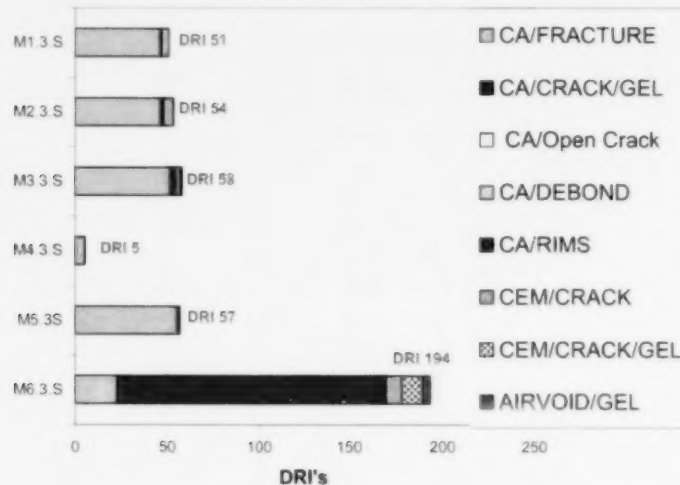
Figure 7. Damage Rating Indices for 12-Year Cores from Outdoor Exposed Slabs

Polished slabs were examined using the Damage Rating Index developed by P. Grattan-Bellew (Dunbar and Grattan-Bellew, 1995). The ratings are shown in Figure 7. All of the values ranged from 50 to 60 except for the high-alkali cement mix, which had 194, indicating extensive damage due to ASR, and for mix 4 with a very low DRI of 5. Values less than about 50 indicate no ASR damage and, in Mixes 1, 2, 3, and 5, most of the ratings are caused by fractures in the coarse aggregate and are not necessarily ASR-related. However, some signs of ASR were found in some of Mixes 1, 2, 3, and 5 using SEM and petrographic analysis.

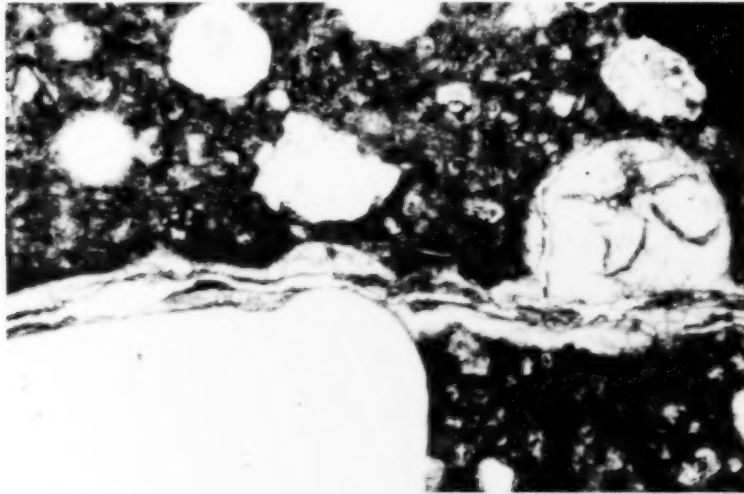
Figure 8. Concrete from Mixture 6 (high-alkali cement), plane light, field of view 0.7 mm. Crack in paste is lined and filled with clear alkali-silica gel as is an oval air void. Light-coloured quartz fine aggregate particle in bottom left.

Thin sections of the field concrete taken from the beams and slabs at an age of about 12 years were examined under a petrographic microscope, and polished, epoxy-impregnated sections were examined in the SEM. Concrete from Mixture 6 (high-alkali cement) showed extensive cracking of the coarse aggregate and the cement paste. The amount of cracking was less near the surface of the concrete (e.g. within 25 mm of the top surface of the slabs); it is probable that leaching of alkalis has resulted in less damaging alkali-silica reaction in this zone. Cracks (from about 5  $\mu$ m to 200  $\mu$ m in width) were either found running through the aggregate and into the surrounding paste or found inside the aggregate, close to the edge of the aggregate. It was estimated that about 30 to 50% of the coarse aggregate particles showed these internal cracks. The cracks that were found in the cement paste were lined or filled with a clear alkali-silica gel. Air voids close to the cracks were often lined or filled with the same gel (Figures 8 and 9). On fractured surfaces, thin crusts of clear alkali-silica gel were readily found coating irregular large void surfaces or lining air voids. EDX analysis in the SEM indicated that the gel found in air voids and in cracks in the mortar was rich in calcium, whereas the gel found in the opening of cracks in the aggregate had a high-alkali ( $K^+$ ) content (see Figure 9). The cracks found in the aggregate were not filled with gel, but with an acicular crystalline material with low birefringence (Figures 10 and 11), although some cracks were empty (i.e. did not contain reaction product). In transmitted light, this material had a light-brown colour in thin section and, in reflected light, was either

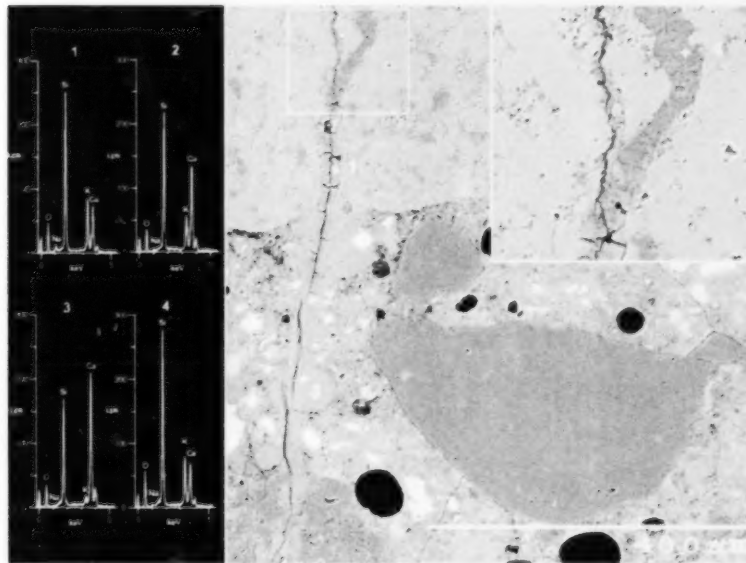
Figure 9. SEM Micrograph of Concrete from Mixture 6 showing alkali-silica gel exuding from a crack in aggregate into a crack and adjacent air voids in surrounding paste.

white or had a light blue colour. The acicular crystalline material had the elemental composition shown in Figure 9 (Spot 4) (i.e. approximately equal amounts of potassium and calcium with minor sodium and a strong indication of silica). This material is similar in appearance and chemistry to that described by Shayan and Lancucki, 1986, who described a crystalline material with x-ray characteristics and chemistry very similar to that of the mineral Okenite ( $\text{Ca}_{10}\text{Si}_{18}\text{O}_{46}\cdot 6\text{H}_2\text{O}$ ). This Okenite-like material has been previously described in concretes with alkali-silica reactive siliceous limestones of Quebec and Ontario by Fournier et al, 1986, as well as with many different aggregates by a number of authors (Shayan and Lancucki, 1986). Not all alkali-silica reactions show this mineral and it is considered uncommon. However, in previous studies of field-damaged concrete from Ontario made with the Spratt aggregate and similar siliceous limestones, this mineral has often been found. It is notable that this Okenite-like material was only found in cracks in the coarse aggregate and was not in the cracks in the adjacent paste where only alkali-silica gel was found, although gel was also typically found in the entrance of cracks in the aggregate up to a depth of  $\sim 100\text{ }\mu\text{m}$ . Figure 12 shows the transition from brown, birefringent, Okenite-like material in the coarse aggregate to clear gel in that part of the crack in the mortar. The minerals calcite and ettringite were found lining some air voids, but not in excessive amounts.

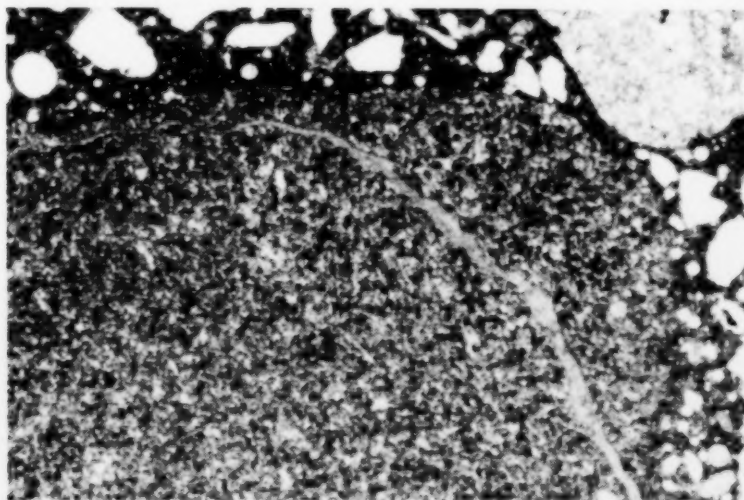
Figure 10. Concrete from Mixture 6 (high-alkali cement), plane light, field of view 4.5 mm. Crack in limestone coarse aggregate is filled with light brown-coloured, crystalline product of ASR.

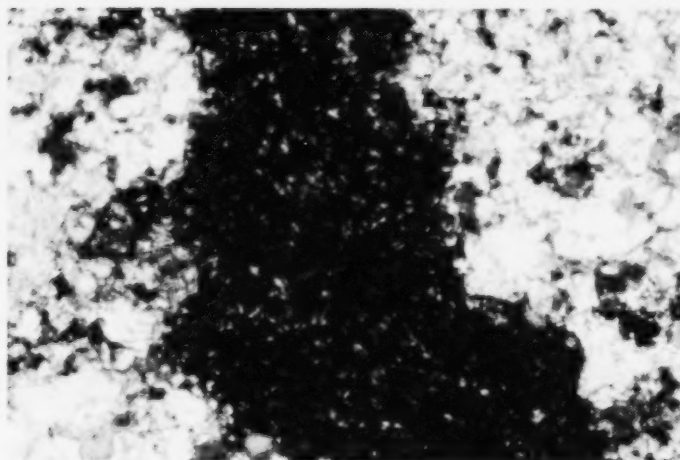
Figure 11. Cherty Limestone, cross-polarized light, field of view 0.35 mm. Crack in coarse aggregate from Mixture 6 (high-alkali cement) is filled with crystalline secondary material; on either side of crack is high birefringence fine crystalline calcite. In cross-polarized light, low birefringence with first order interference colours and clusters of crystals can be seen.

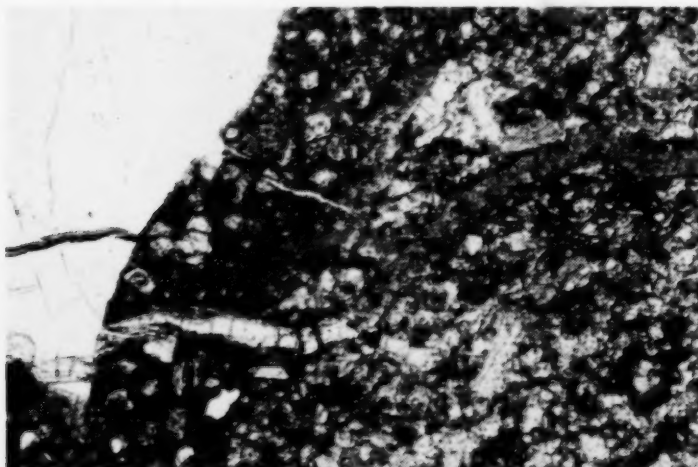
Figure 12. Concrete from Mixture 6 (high-alkali cement) in plane light, field of view 0.7 mm. Coarse aggregate particle of limestone on right is cracked with crack filled with crystalline material. Close to the coarse aggregate boundary with paste the fill material changes to alkali-silica gel.

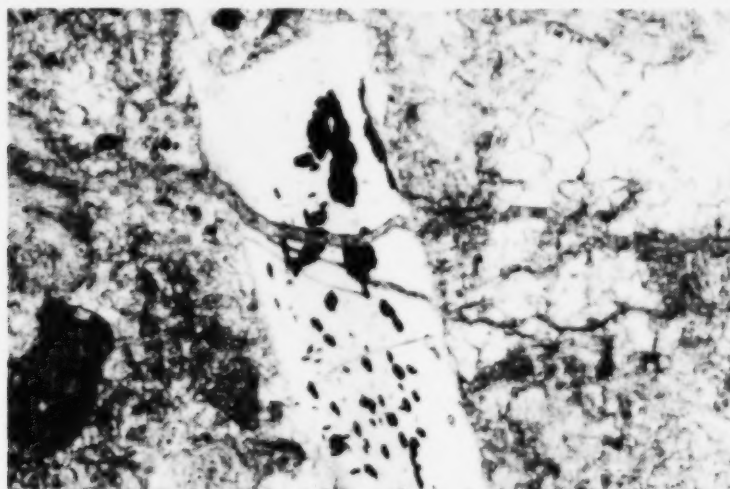
Figure 13. Cherty Limestone Coarse Aggregate, Mixture 5 (low-alkali cement), plane light, field of view 0.7 mm. Coarse aggregate is cracked with crack filled with light brown-coloured crystalline secondary material. Black areas are pyrite; clear oblong crystal is silica surrounded by sparry calcite.

Mixture 5, which was made with low-alkali cement, also exhibited appreciable signs of alkali-silica reaction and damage, e.g. cracks in aggregate particles with brown birefringent reaction product (Figure 13), cracks extending into the surrounding paste (in some cases, containing ASR gel, but more often not), and air voids adjacent to reactive aggregate particles partially filled with ASR gel. However, the amount of cracking and products of reaction were significantly less than found in Mixture 6.

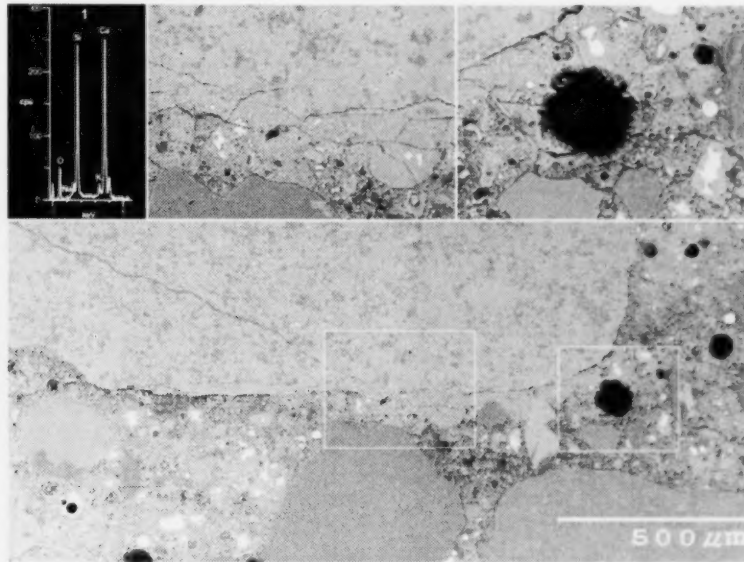
Figure 14. SEM Micrograph of Concrete from Mixture 2 (18% Type F fly ash) showing crack in aggregate with ASR gel flowing into crack and air voids in paste. The gel in the air voids was rich in calcium.

Mixtures 2 and 3, which contained 18% Type F fly ash and 25% blast-furnace slag, respectively, exhibited signs of ASR. In both concretes, ASR gel was found in cracks and voids in the paste and the Okenite-like material was found in cracks in the aggregates (Figures 14 and 15); however, the number of incidences of damage and reaction product was much less than in Mixture 6 and less than in Mixture 5.

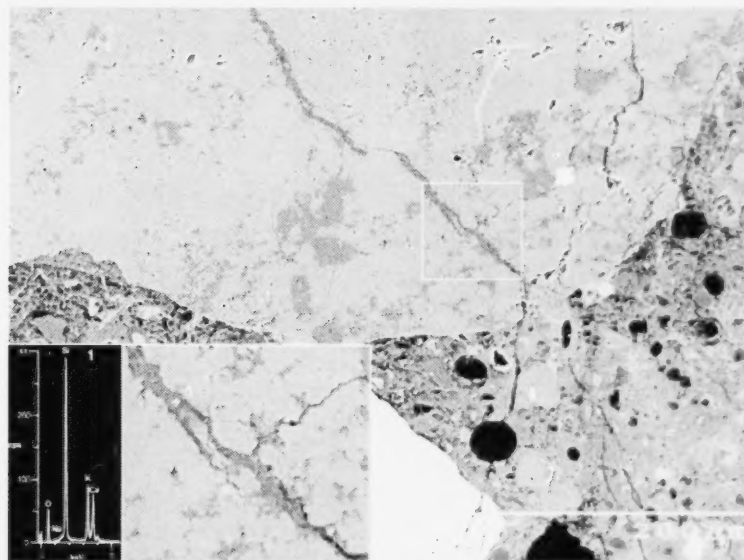
Figure 15. SEM Micrograph of Concrete from Mixture 3 (25% ggbfs) showing a crack in coarse aggregate filled with crystalline mineral and cracks extending in paste.

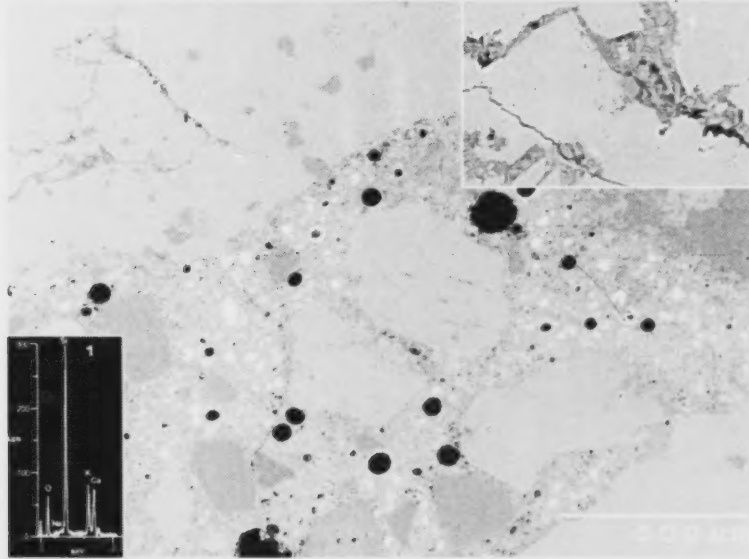
Figure 16. SEM Micrograph of Concrete from Mixture 4 (3.8% sf + 25% GGBFS) showing internal crack in coarse aggregate filled with crystalline reaction product.

There were very modest signs of ASR in Mixture 4, which contained 3.8% silica fume and 25% slag. Although not extensive, some fine internal cracks containing the acicular crystalline reaction product were observed in the coarse aggregate particles, with fine cracks extending into the cement paste (Figure 16). The reaction product that was found had a high potassium content similar to that of the brown birefringent Okenite-like material. No ASR gel was found in the paste or in voids.
